PHENIX WEEKLY PLANNING

5/07/2009
Don Lynch

Shutdown '09 Major tasks (expect 5 month shutdown):

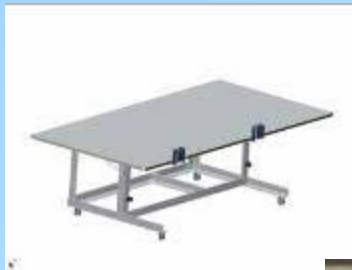
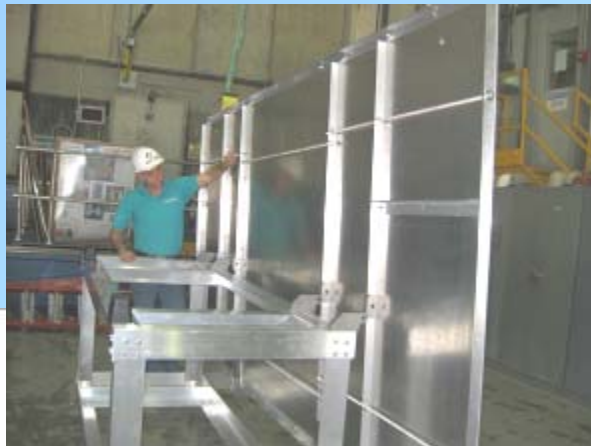
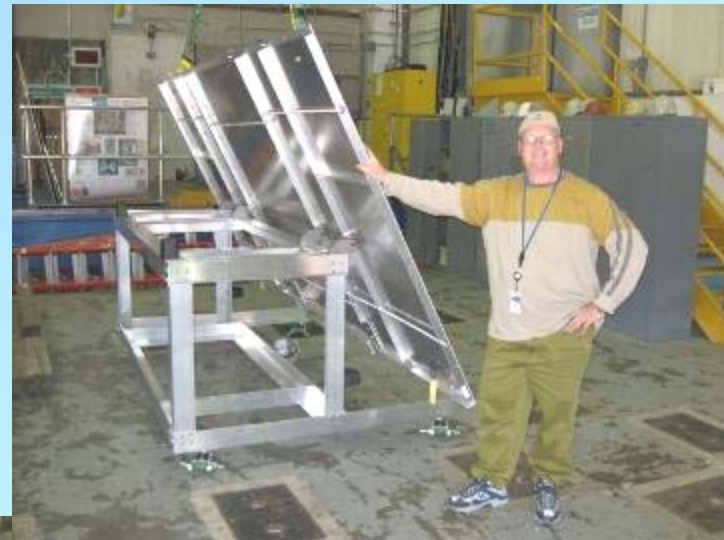
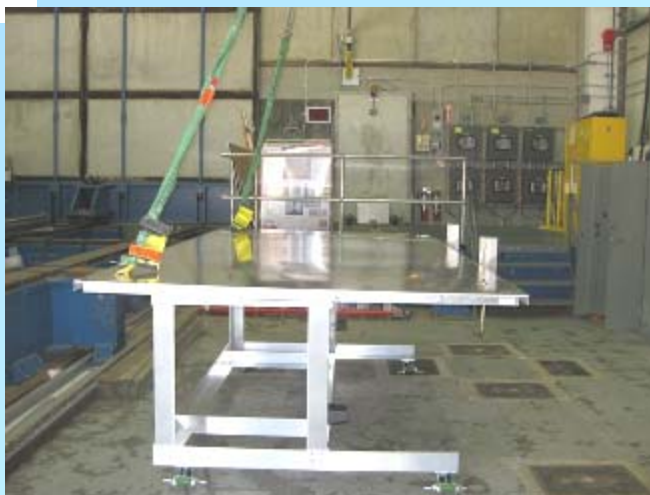
Tilting Transport Table

Ready for Field Testing and field adjustments

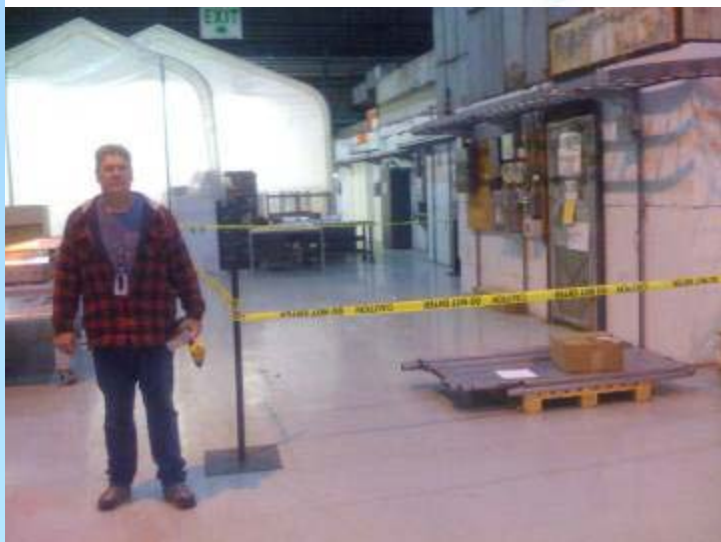
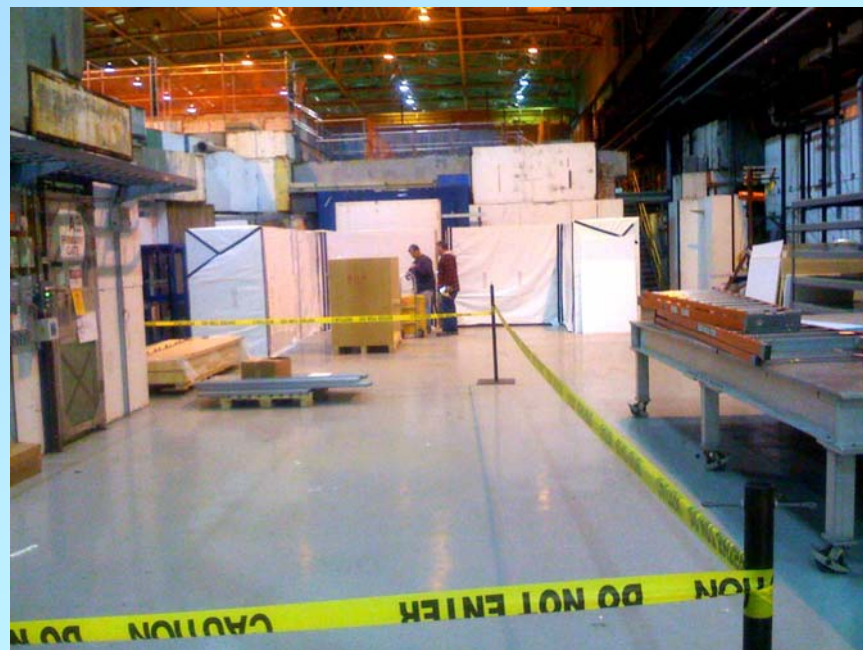
RPC Factory Burn In Test Station For Octant and Half Octant Burn-in Tests

Assembly to begin soon

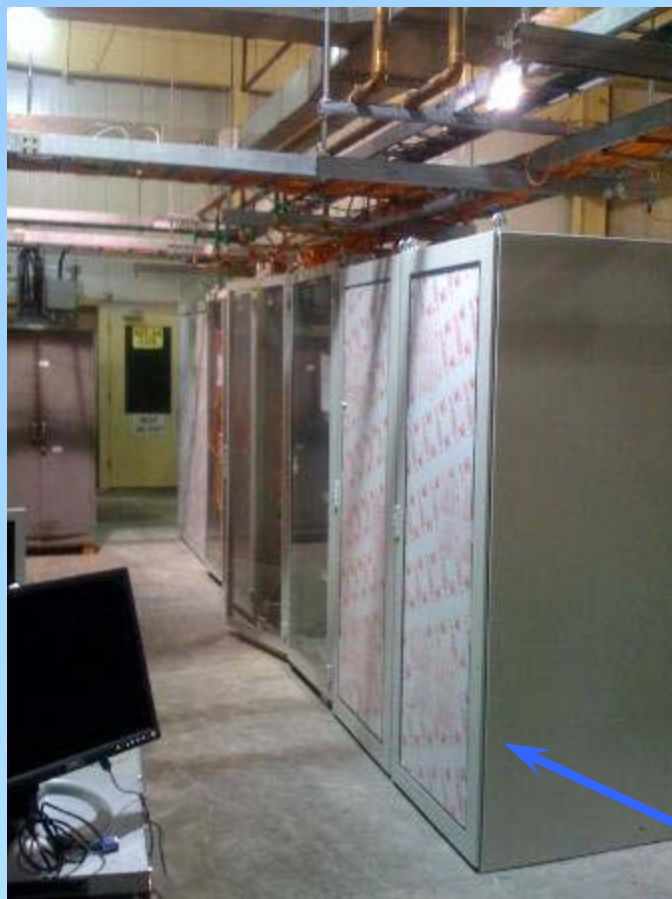
New DCM Rack Plumbing

4 new DCM racks need cooling water plumbing
